**RADIOLOGICAL DECONTAMINATION OF ARMORED PERSONNEL  
CARRIERS WITH CONTINUOUS AND PULSED WATERJETS AT  
UMEÅ, SWEDEN**

W. Yan, A. Tieu, B. Ren and M. Vijay  
VLN Advanced Technologies Inc.  
Ottawa, Ontario, Canada

ABSTRACT

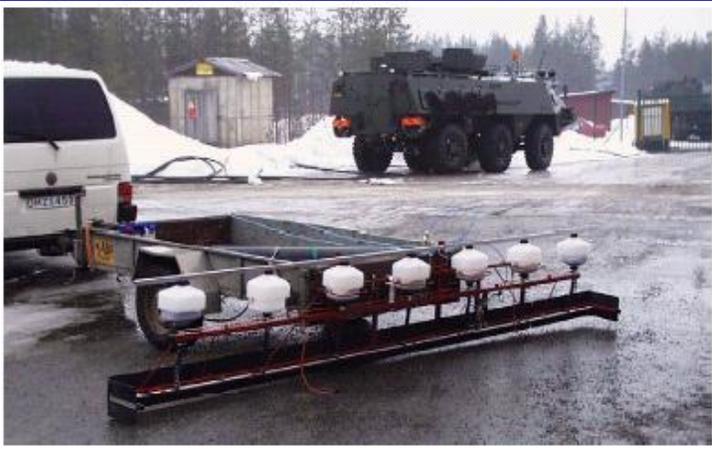
Figure 1. The vehicle used for spreading the radioactive sodium (Na-24) on the track. The seven plastic containers are each filled with an equal amount of sand and sodium.

These experiments took place in the NBC test facility (NBC-Bana) of the Swedish NBC Defence Centre (Totalförsvarets Skyddscentrum) in Umeå, Sweden. Sodium-24 in the form of powdered sodium silicate was mixed with sand and loaded into the seven containers in the trailer depicted in Figure 1. The driver of the van pulling the trailer can activate a switch that empties these containers slowly through the vertical tubes shown below the plastic containers. The tubes are oscillated left and right to produce a more uniform deposition pattern on the ground. The radioactive material was set down on a 4.2-metre wide, 500-metre circumference track. The material was released at a constant rate, so variations in road contamination were achieved by driving the van at different speeds over different segments of the track. Road conditions were wet and icy, and the surface was roughed up by a snowplow prior to spreading of the material. Weather conditions during the trials consisted of light freezing rain.

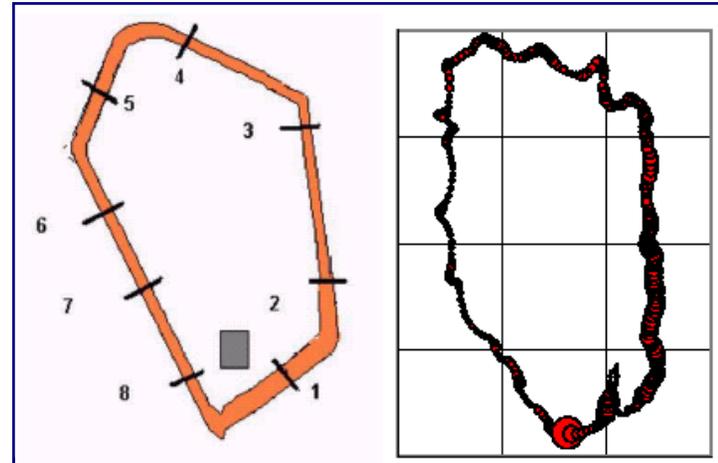
Figure 2. A sketch-map of the contaminated road at the test facility of the National NBC Defence Centre at Umeå.

Figure 2 shows two maps of the road. The first (on the left) is a sketch; the second is a “bubble plot” showing the dose rates at 1-m above the ground around the track, as measured by a BTI Microspec-3 mapping gamma-ray spectrometer Anon (1999). The areas of the bubbles are proportional to the dose rates. The dose rates in turn are proportional to the contamination level on the road. Based on the microshield calculations, Anon (1998), the total Sodium (Na-24) contamination level on the road was estimated to be about 0.56 MBq/m<sup>2</sup>, or 1.2 GBq on the track.

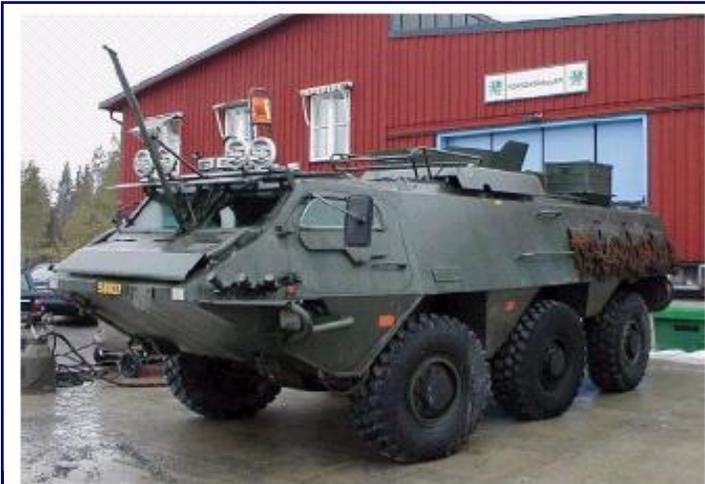
Figure 3. A general view of the SISU XA-180 light armored vehicle.

The test vehicle for the trials was a SISU XA-180 Light Armoured Vehicle, pictured in Figure 3. The XA-180 drove around the contaminated track 10 times, and then returned to the measurement area. The contamination pattern was then characterized with the ABP-100 alpha-beta probe, Anon (2002c), and with swipes. A Swedish team without previous experience of decontaminating the XA-180 then decontaminated the vehicle with the high-pressure hot water spray. This is the same system developed by DRDC Suffield, but without the CASCAD decontaminant foam, Anon (2001a). Following this procedure, the remaining contamination on the vehicle was re-measured. The XA-180 was then driven out onto the track again for 10 laps, before returning to the measurement area. As before, the contamination pattern was characterized. Decontamination trials were then attempted using the *FP* waterjet system. The remaining contamination on the vehicle was again re-measured. The operating parameters of the *FP* machine were:

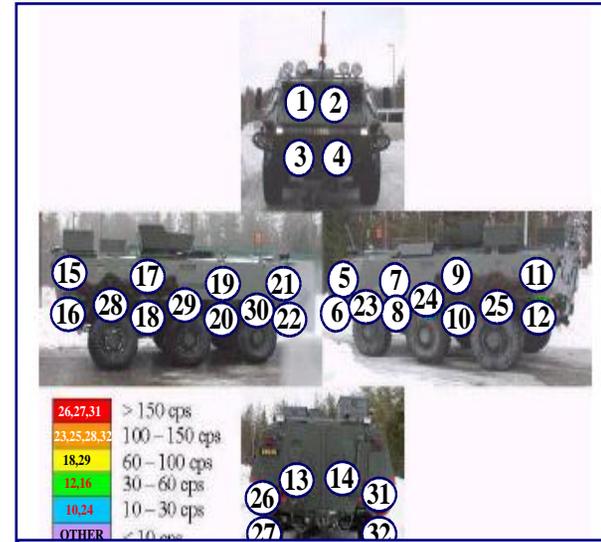
Figure 4. Contamination levels on the vehicle, as measured with the ABP-100 alpha-beta probe (see Table 1)

The most complete characterization of the vehicle contamination was performed with an ABP-100 alpha-beta probe. These measurements are given in Table 1 for both contamination trials (after each 10-lap circuit). The two sets of measurements bear some resemblance to one another, especially in the general trends described below. However, a comparison also reveals that individual contamination measurements at a given position on the vehicle are not reproducible for the two experimental trials. These pairs of measurements varied by up to a factor of five. The average values over the two trials are also shown superposed on the vehicle in Figure 4. The numbers in the circles correspond to the location numbers in Table 1 (those “below detectable levels (BDL)” are not listed).

The contamination levels on the vehicle followed a relatively predictable pattern. Namely, very little contamination was observed on the front or rear of the vehicle, or anywhere on the upper half of the vehicle. On the other hand, significant contamination was noticed on the lower halves of the vehicle sides, especially in the wheel wells. It is worth noting that positions 26, 27, 31, and 32 (Fig. 4) are on or around the two propellers at the rear of this amphibious vehicle. However, because of the vehicle design, this part of the vehicle is essentially part of the wheel wells for the rearmost wheels. These were the most highly contaminated surfaces on the XA-180. It is quite reasonable that the wheel wells were contaminated to the highest level, since the tires are responsible for “kicking up” the contamination. However, it is also worth noting how little contamination accumulated in some of the other areas under the wet conditions prevailing during these trials.

**Table 1.** Count rates on the ABP-100 alpha-beta probe for various locations on the XA-180. A contamination level of 1 Bq/cm<sup>2</sup> would produce a count rate of approximately 30 cps. “BDL” stands for “Below Detectable Limits (locations not listed below)”. Locations are identified in **Figure 4**.

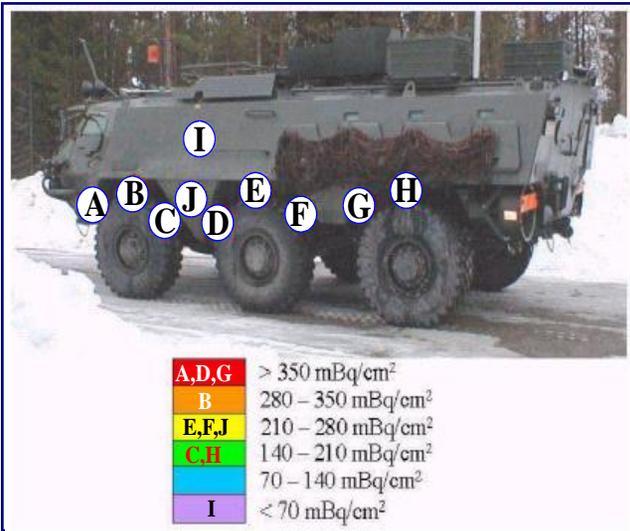
Figure 5. Contamination levels on the XA-180, based on swipe measurements. Locations A-H are on the wheel wells of the vehicle. The letters denoting the positions are used throughout the text.

Contamination levels on the XA-180 were also assessed by swipe tests on vehicle surfaces. Swipes were measured in a Liquid Scintillation Counter (LSC). Such techniques are generally very sensitive assays of removable contamination, although obviously they are not effective for the level of fixed contamination. These locations were primarily in the wheel wells of the vehicle, where probe measurements are more difficult, due to the possibility of probe contamination. The two sets of measurements are shown in Table 2. As was noted above, general trends in contamination levels are consistent in the two data sets (e.g. location ‘I’ is always less contaminated than any other surfaces), although the contamination levels at a given location were far from reproducible. In fact, these data were less reproducible than the probe measurements. The average measurements for each location are superposed on the vehicle as shown in Figure 5, where the letters in the circles correspond to the letters in Table 2. Values in the table are shown as “BDL” if they are consistent with zero given their uncertainties. These uncertainty estimates are felt to be conservative.

Because swipes were taken largely in similar areas, there are few general conclusions that can be drawn about vehicular contamination. However, one can easily see that the swipe data support the earlier observation that contamination did not collect on the upper half of this vehicle. No differentiation can be made, however, between the data collected from the other nine locations.

- **Location B:** Both methods left 10-20% of the initial contamination. This location correlates with probe position 23 (driver's side front wheel well), where residual contamination was also observed with the probe.
- **Location H:** Both methods left 30-50% of the initial contamination. This location corresponds to probe position 25 (driver's side rear wheel well), where decontamination was also observed to be poor according to the probe. It should be noted that the residual percentages are lower for the swipes than for the probes, implying a component of "non-removable" contamination.

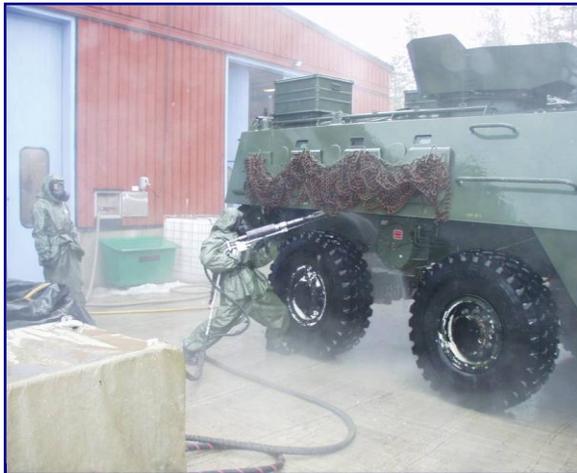
Figure 7. General view showing decontamination in the wheel wells of the vehicle.

- In order to meet the condition listed above, and in order to decontaminate the entire vehicle, very large standoff distances were used (see Figs. 7 and 8). As discussed in the earlier work, at these standoff distances, the pulse disintegrates into droplets and the coherency is lost, Tieu, et. al (2002b). From this standpoint, there was no difference between the **FP** and the conventional systems. The slight advantage, or the disadvantage of migrating (spreading) by

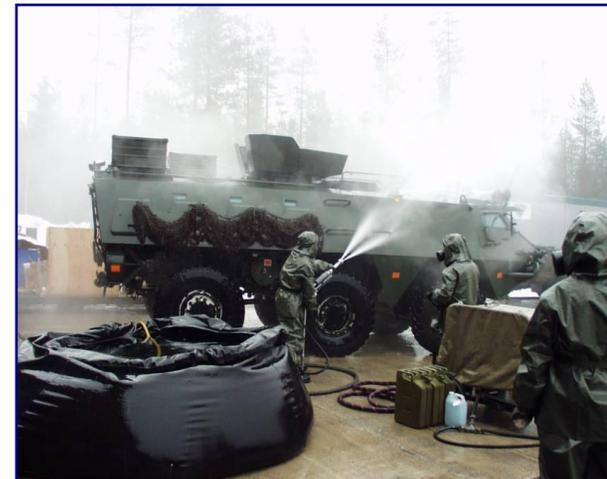
Figure 8. General view showing decontamination on the sides (& front) of the vehicle.
